INSPECTION REPORT  
3912 57th Avenue E  
Bradenton FL 34203

INSPECTED BY  
Ryan Travis - FL#  
HI10255  
2RT Home  
Inspections  
HI10255

INSPECTION DATE  
📅 12/13/2024  
🕒 12:45 PM

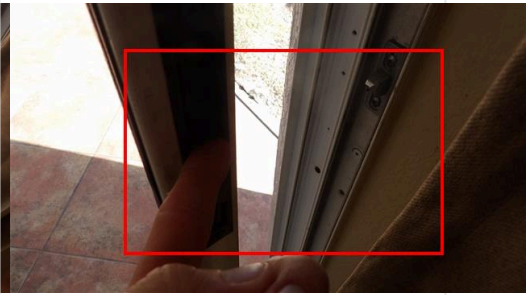
2.1 Item 6 (Picture)

Sliding glass door does not lock properly. Item 6 (Picture) Item 7 (Picture)

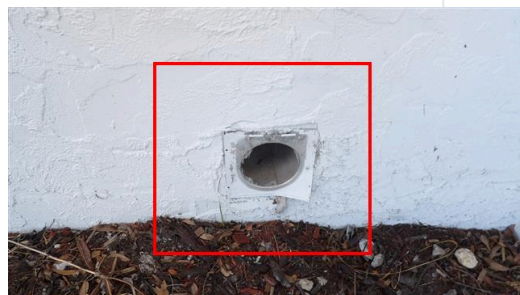
4.15 Item 1 (Picture)

Dryer vent needs a cover. Item 1 (Picture)

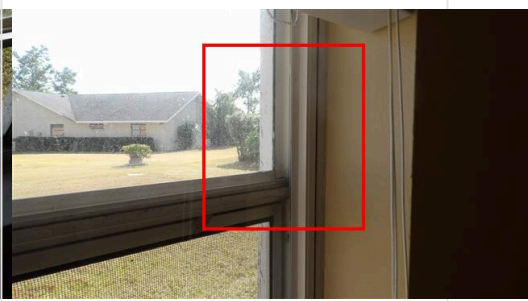
5.5 Item 15 (Picture)

Several windows have broken spring arms that prevent the window from staying open/closing/locking properly. Item 4 (Picture) Item 5 (Picture) Item 15 (Picture) Item 16 (Picture) Item 17 (Picture)

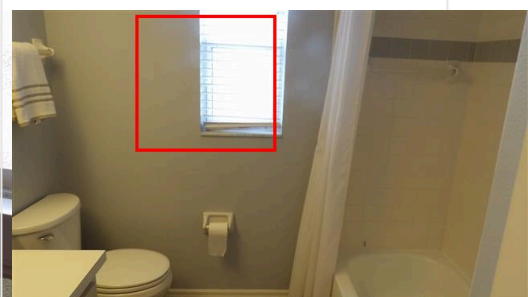
5.5 Item 27 (Picture)

Window in hall bathroom is damaged. Item 26 (Picture) Item 27 (Picture)

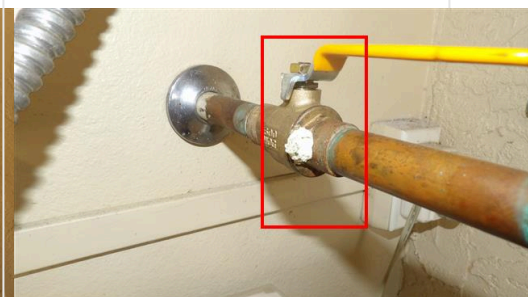
7.2 Item 3 (Picture)

There is slight corrosion on the supply line. Item 3 (Picture)

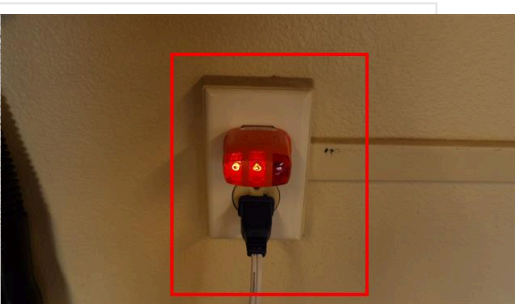
8.5 Item 3 (Picture)

Bathrooms, garage and the stove side of the kitchen outlets do not have proper GFI protection. This is recommended. Item 3 (Picture) Item 4 (Picture) Item 5 (Picture) Item 6 (Picture) Item 7 (Picture) Item 8 (Picture) Item 9 (Picture) Item 10 (Picture) Item 11 (Picture) Item 12 (Picture) Item 13 (Picture) Item 14 (Picture) Item 19 (Picture) Item 20 (Picture) Item 21 (Picture) Item 22 (Picture) Item 23 (Picture) Item 24 (Picture)

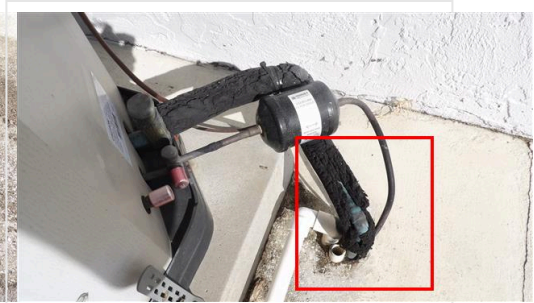
9.8 Item 3 (Picture)

There is deterioration on the insulation for the supply line. Item 3 (Picture) Item 4 (Picture)
