INSPECTION REPORT  
3912 57th Avenue E  
Bradenton FL 34203

INSPECTED BY  
Ryan Travis - FL#  
HI10255  
2RT Home  
Inspections  
HI10255

INSPECTION DATE  
📅 12/13/2024  
🕒 12:45 PM

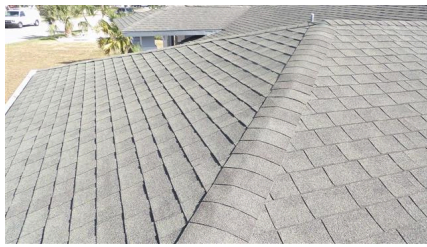
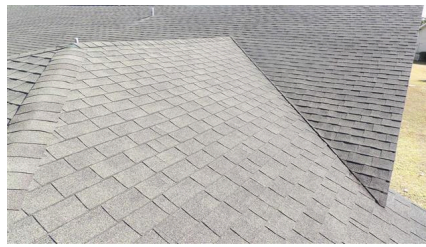
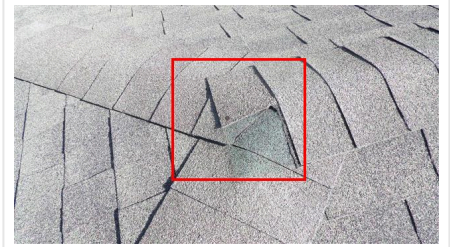
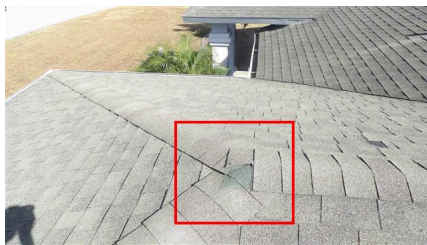
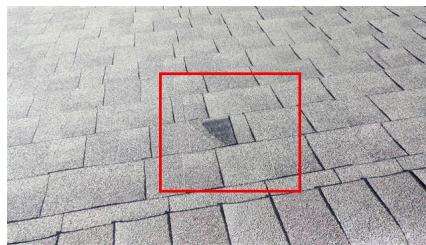
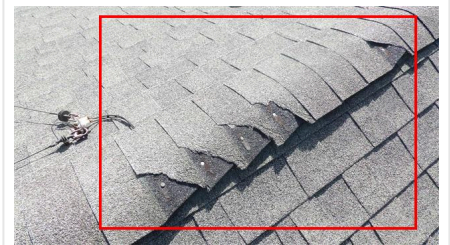
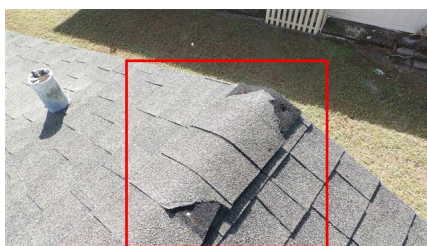
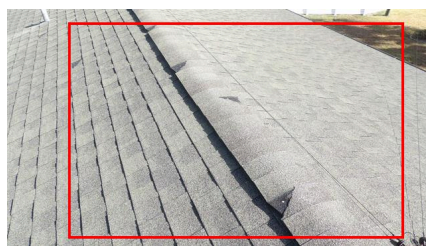
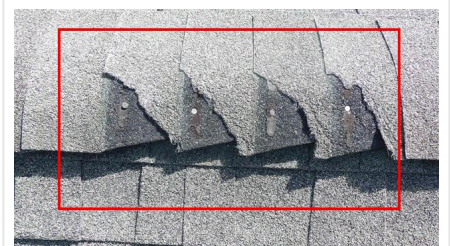
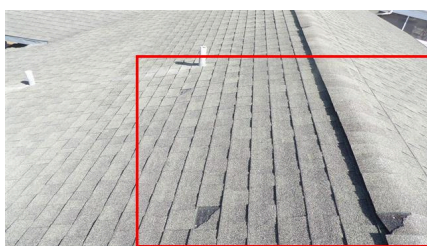
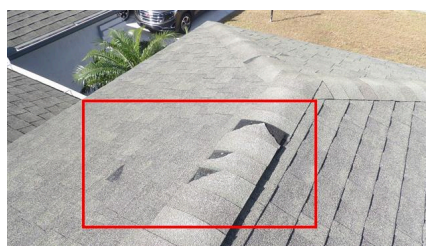
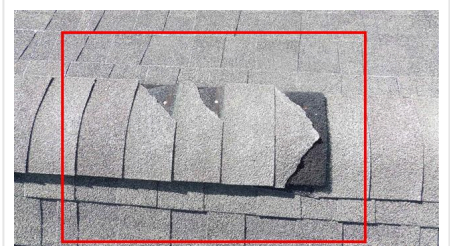
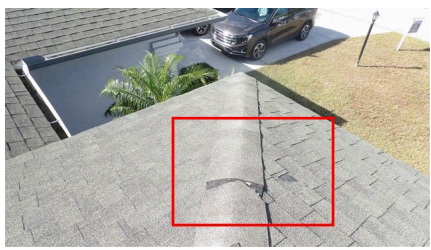
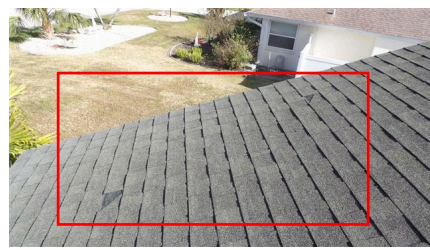
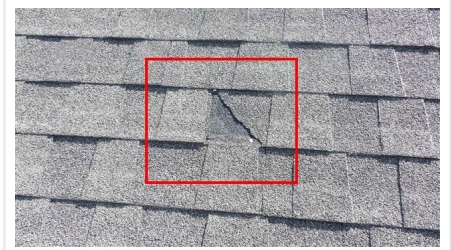
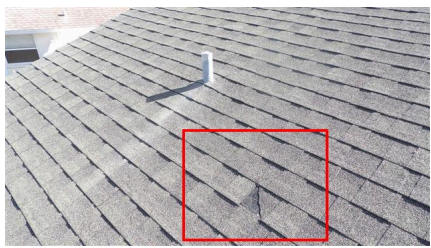
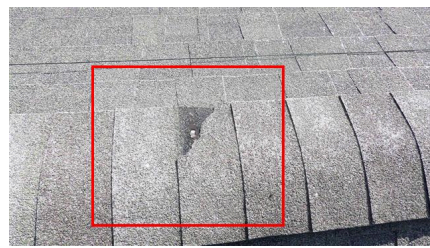
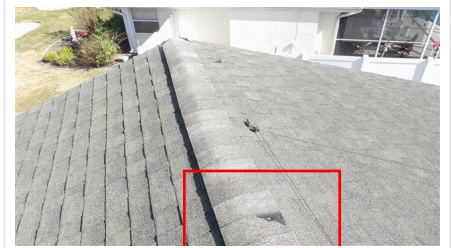
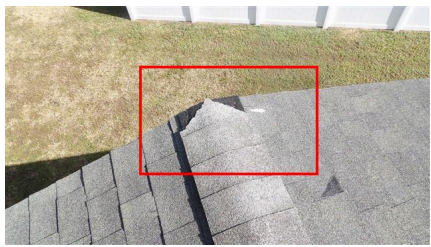
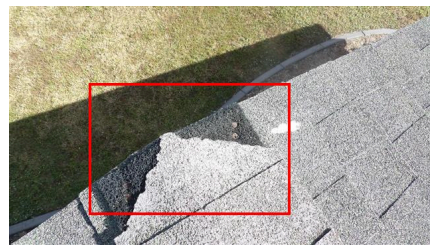
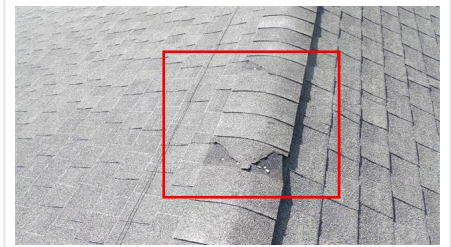
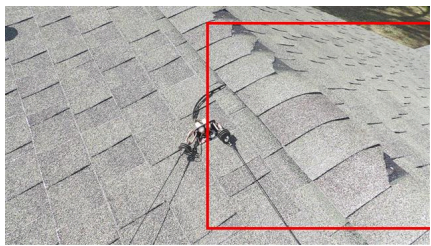
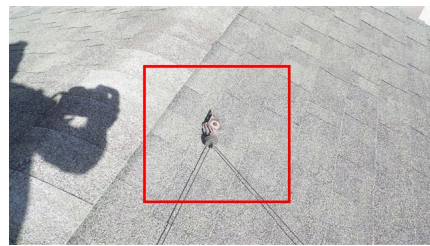
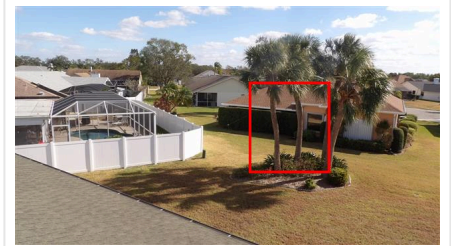
Roof is an asphalt shingle that was installed in 2004 under permit #O4091489 dated 4/29/2004. The average typical lifespan of this type of covering is 20–25 years.

There are damaged shingles and exposed nails. This could lead to potential water intrusion. Item 3 (Picture) Item 4 (Picture) Item 5 (Picture) Item 6 (Picture) Item 7 (Picture) Item 8 (Picture) Item 9 (Picture) Item 10 (Picture) Item 11 (Picture) Item 12 (Picture) Item 13 (Picture) Item 14 (Picture) Item 15 (Picture) Item 16 (Picture) Item 17 (Picture) Item 18 (Picture) Item 19 (Picture) Item 20 (Picture) Item 21 (Picture) Item 22 (Picture)

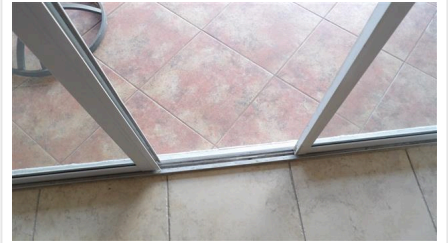
2.1 Item 3 (Picture)

Large sliders rollers are starting to wear. Item 3 (Picture)

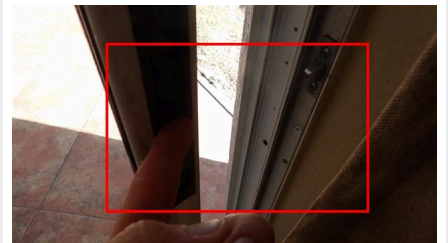
2.1 Item 6 (Picture)

Sliding glass door does not lock properly. Item 6 (Picture) Item 7 (Picture)

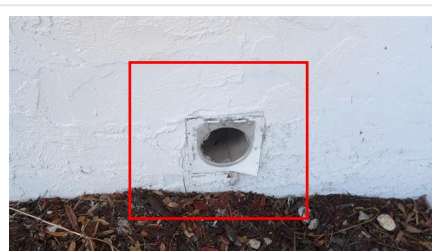
4.15 Item 1 (Picture)

Dryer vent needs a cover. Item 1 (Picture)

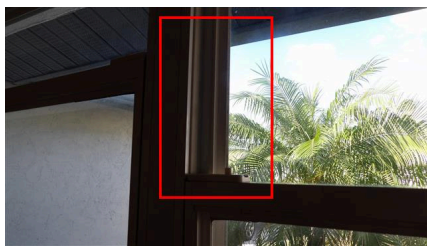
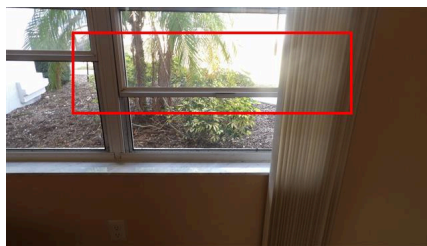
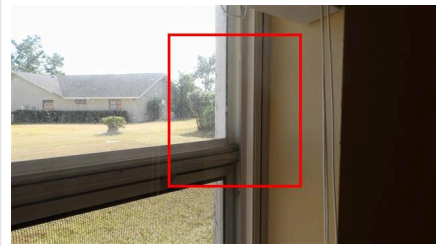
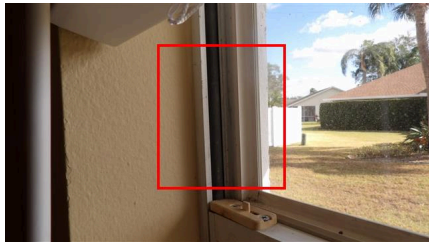
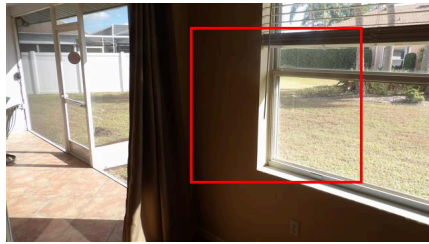
Several windows have broken spring arms that prevent the window from staying open/closing/locking properly. Item 4 (Picture) Item 5 (Picture) Item 15 (Picture) Item 16 (Picture) Item 17 (Picture)

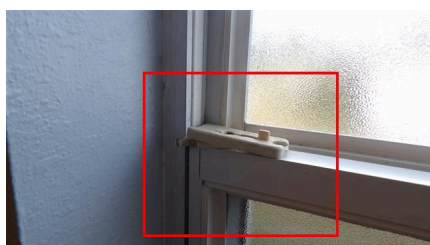
5.5 Item 26 (Picture)

Window in hall bathroom is damaged. Item 26 (Picture) Item 27 (Picture)

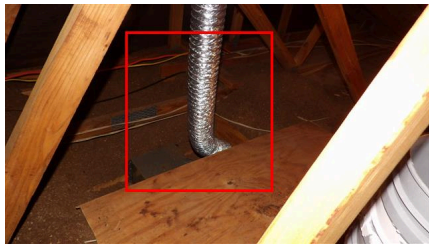
6.9 Item 1 (Picture)

Bathroom exhaust fan does not terminate outside of the home. It terminates in the attic. Item 1 (Picture)  
Item 2 (Picture)

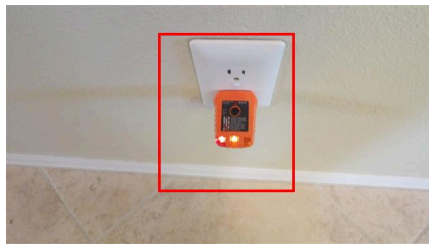
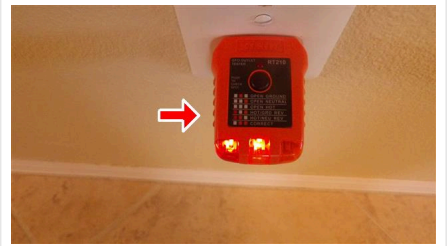
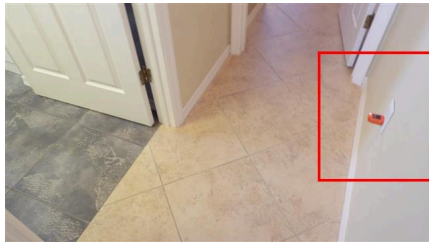
Outlet in the hallway between the two guest bedrooms has the hot/neutral wires reversed. Item 8 (Picture)  
Item 9 (Picture) Item 10 (Picture)

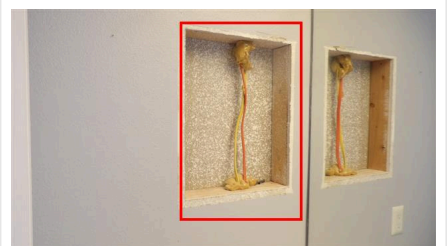
8.3 Item 18 (Picture)

Exposed wiring in the master bathroom. Item 18 (Picture)

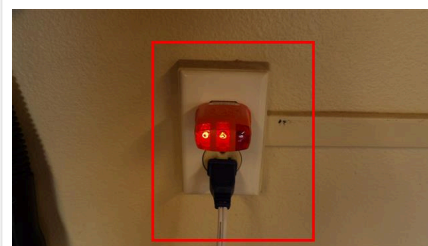
8.5 Item 3 (Picture)

Bathrooms, garage and the stove side of the kitchen outlets do not have proper GFI protection. This is recommended. Item 3 (Picture) Item 4 (Picture) Item 5 (Picture) Item 6 (Picture) Item 7 (Picture) Item 8 (Picture) Item 9 (Picture) Item 10 (Picture) Item 11 (Picture) Item 12 (Picture) Item 13 (Picture) Item 14 (Picture) Item 19 (Picture) Item 20 (Picture) Item 21 (Picture) Item 22 (Picture) Item 23 (Picture) Item 24 (Picture)

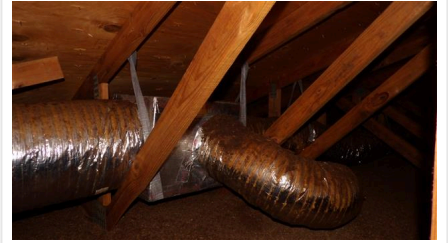
9.3 Item 3 (Picture)

There is deterioration on the insulation for the supply line. Item 3 (Picture) Item 4 (Picture)

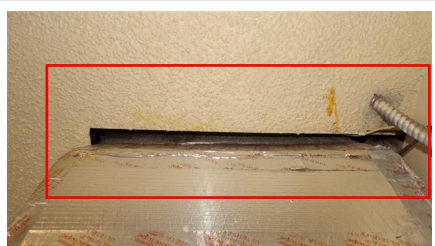
9.8 Item 8 (Picture)

There is a gap at the ceiling above the air handler. This could allow warm air from the attic to the cooler air below potentially leading to mold around the air handler. This should be sealed. Item 8 (Picture)

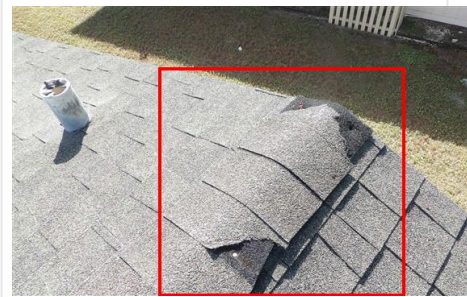
1.0 Item 7 (Picture)

There are damaged shingles and exposed nails. This could lead to potential water intrusion. Item 3 (Picture) Item 4 (Picture) Item 5 (Picture) Item 6 (Picture) Item 7 (Picture) Item 8 (Picture) Item 9 (Picture) Item 10 (Picture) Item 11 (Picture) Item 12 (Picture) Item 13 (Picture) Item 14 (Picture) Item 15 (Picture) Item 16 (Picture) Item 17 (Picture) Item 18 (Picture) Item 19 (Picture) Item 20 (Picture) Item 21 (Picture) Item 22 (Picture)

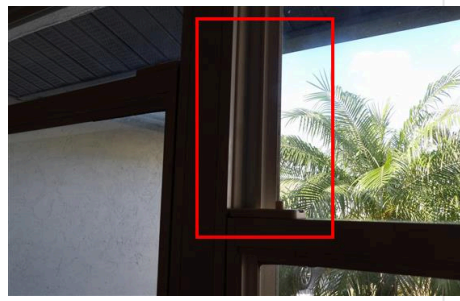
5.5 Item 4 (Picture)

Several windows have broken spring arms that prevent the window from staying open/closing/locking properly. Item 4 (Picture) Item 5 (Picture) Item 15 (Picture) Item 16 (Picture) Item 17 (Picture)

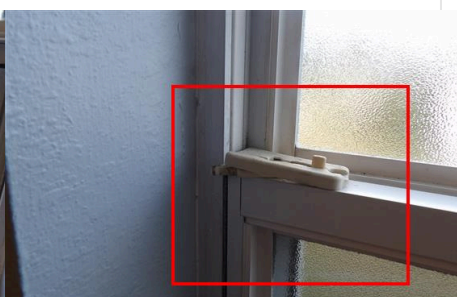
5.5 Item 26 (Picture)

Window in hall bathroom is damaged. Item 26 (Picture) Item 27 (Picture)

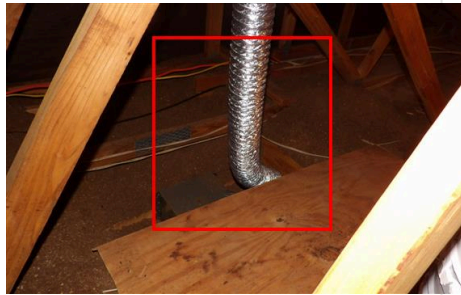
6.9 Item 1 (Picture)

Bathroom exhaust fan does not terminate outside of the home. It terminates in the attic. Item 1 (Picture) Item 2 (Picture)

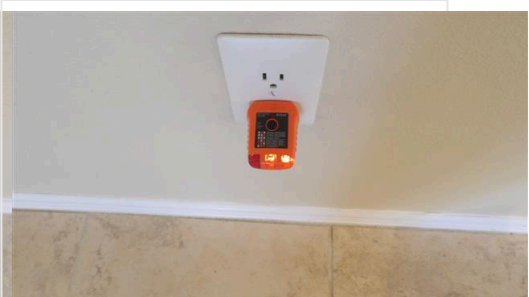
8.3 Item 3 (Picture)

Bathrooms, garage and the stove side of the kitchen outlets do not have proper GFI protection. This is recommended. Item 3 (Picture) Item 4 (Picture) Item 5 (Picture) Item 6 (Picture) Item 7 (Picture) Item 8 (Picture) Item 9 (Picture) Item 10 (Picture) Item 11 (Picture) Item 12 (Picture) Item 13 (Picture) Item 14 (Picture) Item 19 (Picture) Item 20 (Picture) Item 21 (Picture) Item 22 (Picture) Item 23 (Picture) Item 24 (Picture)

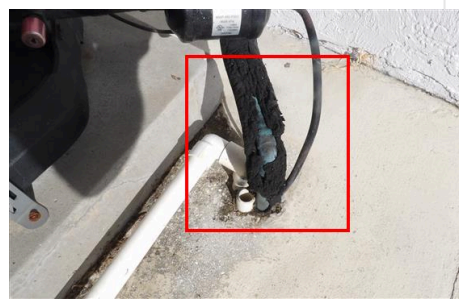
9.8 Item 4 (Picture)

There is deterioration on the insulation for the supply line. Item 3 (Picture) Item 4 (Picture)
